5" ULTRA FLO SUCTION INSTALLATION INSTRUCTIONS

For Model Number: 640-393x V

VGB 2008

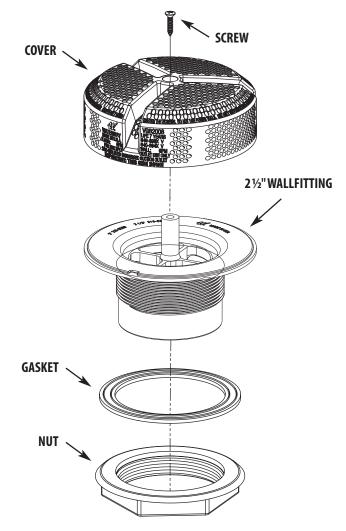
- 1. Locate and cut a 3 ¼" hole in a vertical wall of the spa. Be sure the area located is flat and spa laminate thickness is uniform.
- 2. Insert wallfitting with gasket through hole.
- 3. Apply a bead of silicon against the back wall of the spa and around the threads of the wall fitting . Avoid getting sealant on gasket.
- 4. Install nut and tighten. Be sure wallfitting screw studs are horizontal to bottom of spa.
- 5. Glue elbow supplied with fitting into wallfitting. Be sure to orient the elbow in the required direction while gluing.

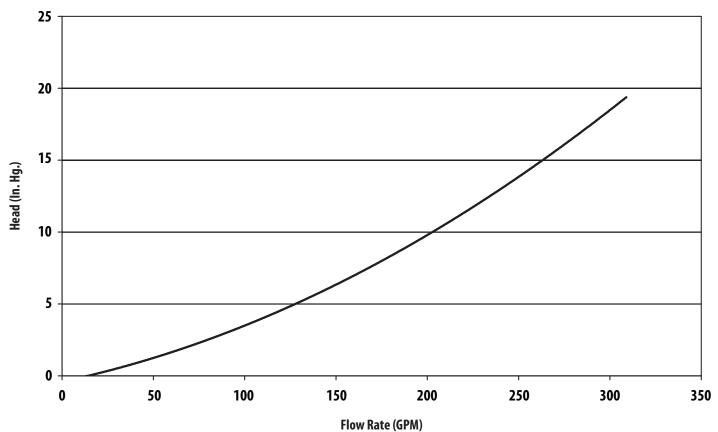
640-393x V Head Loss Curve

The 640-393x V fitting is rated at 224 GPM for wall only application. If the fitting is missing or broken, replace with a fitting of equivalent rating or higher. Use of a lower rated suction fitting could result in entrapment of the body which could result in serious injury including drowning.
